Manhole Inspection Summary

Manhole # S13QQ1003MH

Insp Date: **11/2/06 9:00 AM**

Location Address: **2700 CYLBURN AVE**

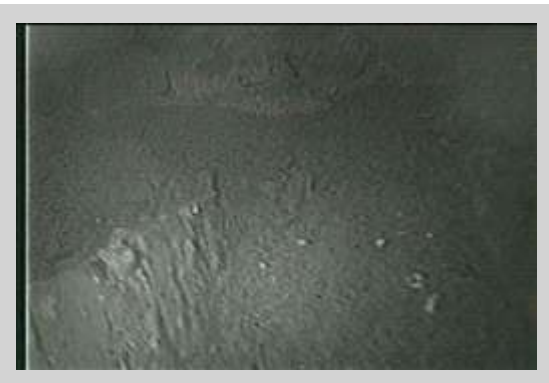
Pipe In @ 3 O'Clock

Pipe Material: ☐ Pipe Lined

Invert Depth: (ft.) Flow Characteristics: **None**

Infiltration: **None** Pipe Seal Cond: **Unknown**
